Rehabilitation of the Old Naval Hospital

A Technical Report

Friends of the Old Naval Hospital

January 30, 2002
Friends of the Old Naval Hospital
907 E Street SE
Washington, D. C. 20003
202-544-4627

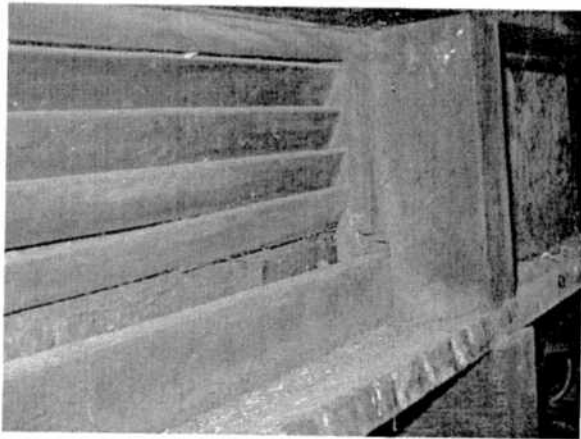
Original: The original roof configuration remains with its integrated gutters. The building's ventilation system vented originally through openings at the area where the roof steps up, just below the widow's walk. The underlying structure (wood) is original and only lightly repaired over the years.

Blocked Vents

D. Recommendation: The roof and drainage work must be done by qualified roof restoration specialists and not just a low bid roofer. The specifications must be written so that the bidder has to prove current experience and background in historic roof restoration of this period with at least five examples of similar work in the last seven years. In addition, the bird droppings and other loose materials must also be removed and screens installed to prevent bird penetration under the roof.

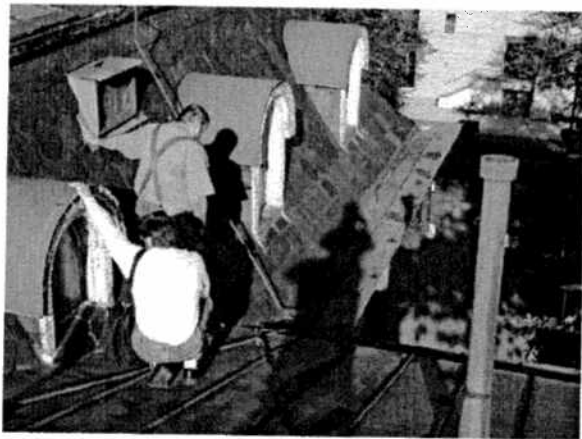
Current: The slate on the roof is in generally good shape, with some replacement needed in specific areas where there has been exfoliation and cracking of the slate. Some slate shingles are missing. The seamed metal part of the roof seems watertight, but needs to be lightly scraped, repaired and painted. The interior of the roof is for the most part, totally dry and without problems, with only a few hints of leakage which need to be repaired. There have been some minor repairs to the interior structure over the years.

Roof and Dormers

Description: No extensive restoration is needed although the areas showing some water leakage needs to be investigated and repaired. The seamed metal roof needs to be completely cleaned and thoroughly repaired and then painted in the color of the original paint (probably a green—this must be determined by a paint analysis) with a fibrous sealant paint. For the slate part of the roof, period slate shingles must be replaced in kind.

The roof work should be done at an early stage in the restoration. Preliminary work on paint analysis should be started and repair of the seamed metal and repainting done at an early stage. The slate shingles which need to be replaced must be matched and therefore researched

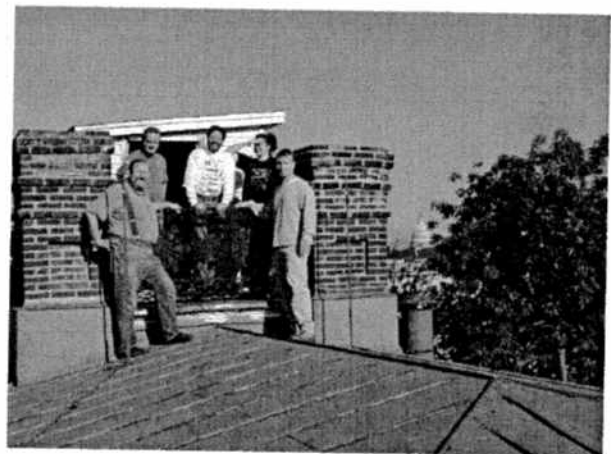
Chimney and Metal Roof

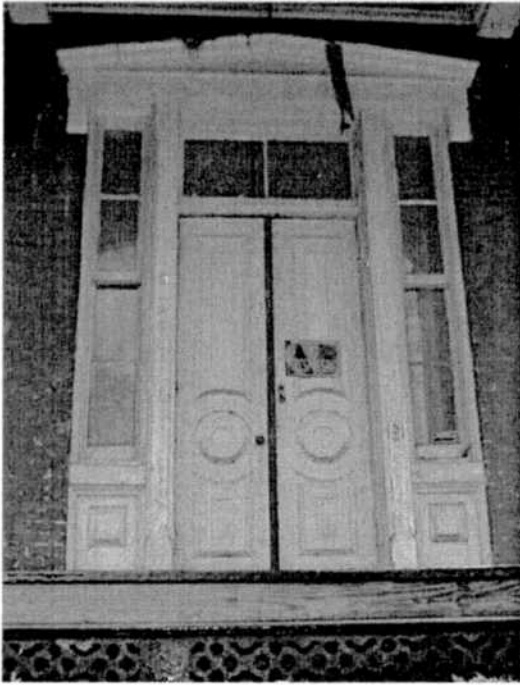
Type A Door

Description: Type A door needs to have some of the hardware replaced and paint scraped and repainted, as well as removal and redo of previous repairs.

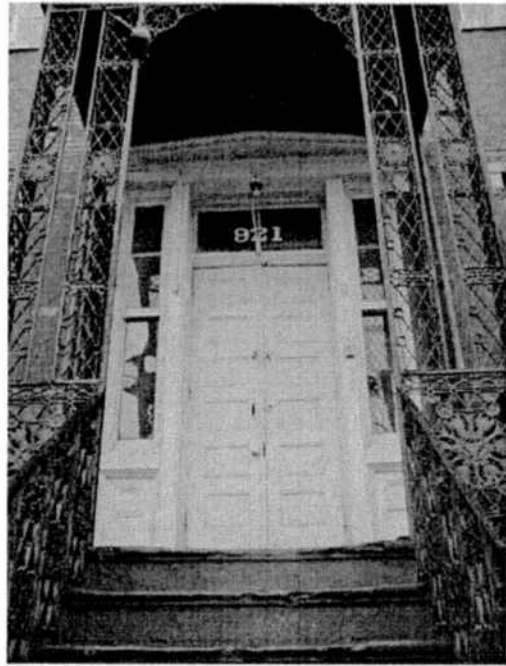
Type B Door

Type B door also needs scraping and repainting as well as having the sidelights repaired and reglazed with replacement of glass, one hinge needs to be replaced by a reproduction of the existing hinges. Research on the light over the door needs to be done for restoration. Sidelights are double hung so weights and pulleys must be restored.

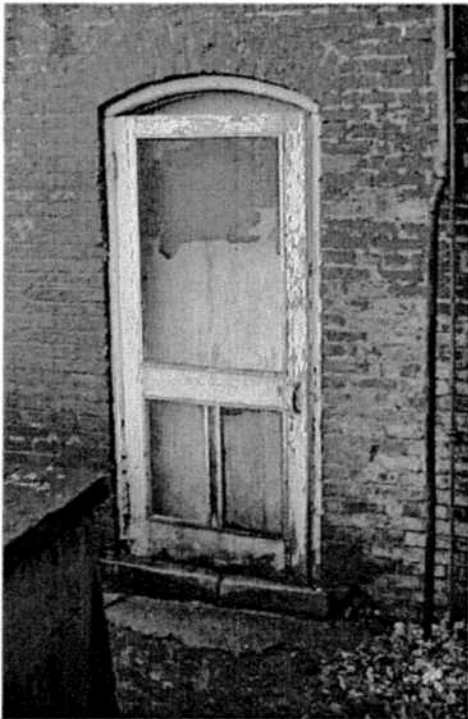
Type C Door

Type C door on the west elevation needs to be scraped and repainted and old repairs done correctly. New glass is required and the surround needs to be repaired. The inside condition is good. On the Type C door on the east elevation, major restoration will be required using the other Type C door as reference.

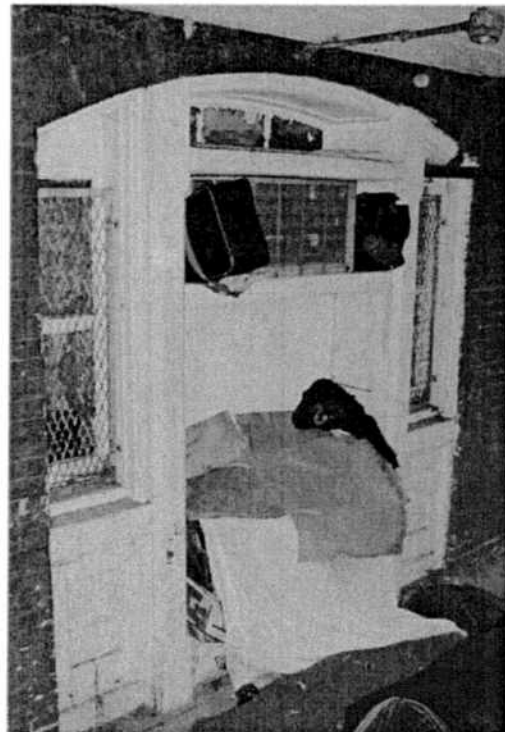
Type D Door

The Type D door is still there but sealed in with plywood and needs scraping and repainting and the casement windows need to be restored to working condition.

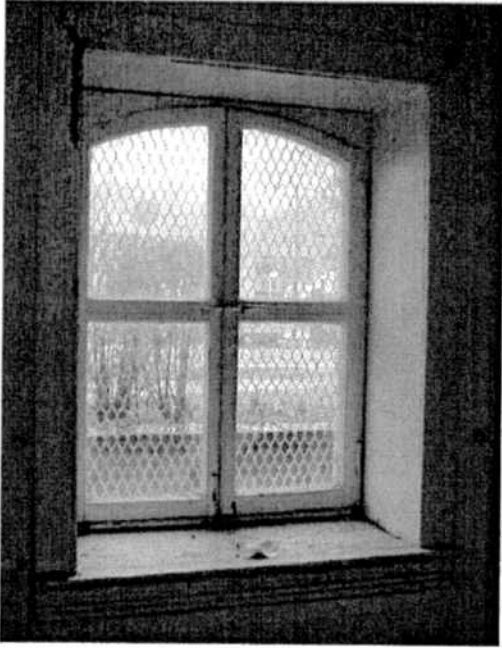
Basement Type 2 Windows

Current: The Type 2 windows are in reasonably good shape needing only restoration. There is some original hardware which can be restored. The type 2 windows sashes need replacing with sashes similar to the extant Type 2 units. The type 3, 4 and 5 windows need to be researched and replaced.

Original: The best example of the Type 2 window is the second window in from the northwest corner. The surrounds and windows are in good shape on the original windows, needing only restoration. Hardware needs to be restored and where missing, replaced in kind.

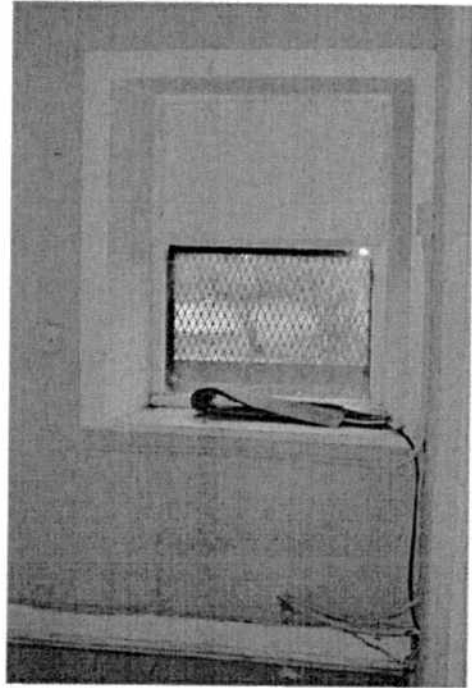
Basement Type 3 Window

Added: The AC units are in poor shape, but should be eliminated regardless. The Type 3, 4 and 5 windows need to be replaced.

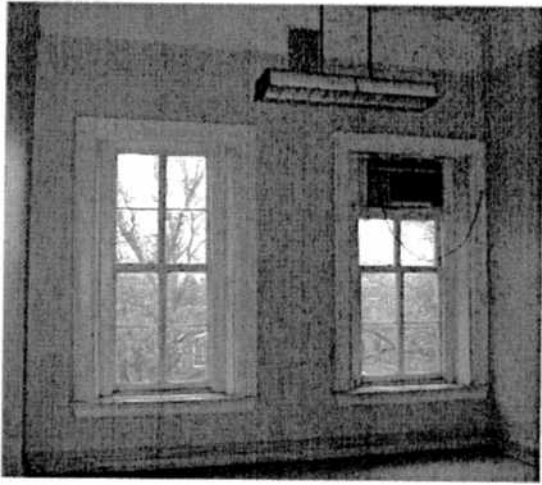
First Floor: Type 6 and 7 Windows

Current: Both type windows are in good shape. The air conditioning units are in need of replacement (or elimination).

Original: The Type 6 windows are missing the top half of the upper sash where the AC unit was inserted. The lower sash is restorable while the upper sash was significantly altered. There are some muntins missing and there is inappropriate sealant on some of the windows.

Inappropriate sealant was used on some windows for glazing the exterior. The wood stool is severely deteriorated and most of the windows have missing hardware, although some have the cord and weights from the double hung movement. Some windows have mismatched glass (eg. obscure or wired). Some interiors have been inappropriately stripped of paint.

Added: The air conditioning units need to be replaced (or eliminated).

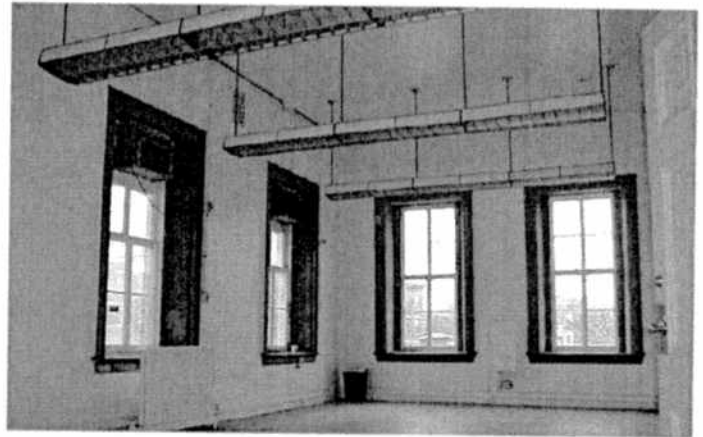
Second Floor Type 8 and 9 Windows

Current: Type 8 windows are similar in condition to the Type 6 windows on the first floor. There is early glass in the lower sash of the window second from the left on the north elevation.

Type 9 windows are similar in condition to the Type 7 windows on the first floor. There is early glass (broken) in the second window from the right on the east elevation and five panes on the left most window on the east elevation. There is also evidence of interior shutters separately for the upper and lower sashes as indicated by the hinge recesses in the interior jambs next to the sashes.

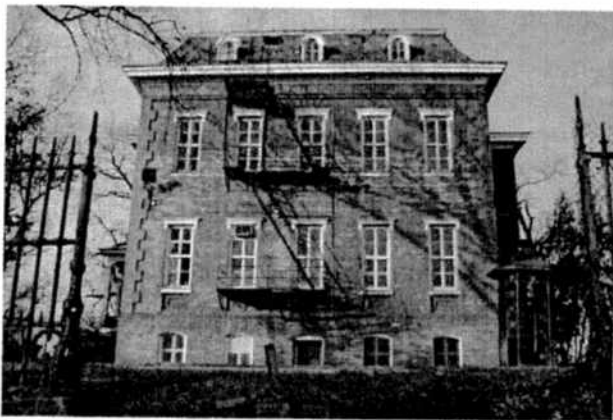
Third Floor: Type 10 Window

Current: The Type 10 windows have open joints in the sash and are temporarily reinforced, with severely damaged stools and two with non-original five knuckle hinges. Three of them have the original two knuckle hinges and the window on the east elevation at the northeast corner has what appears to be early or original glass.

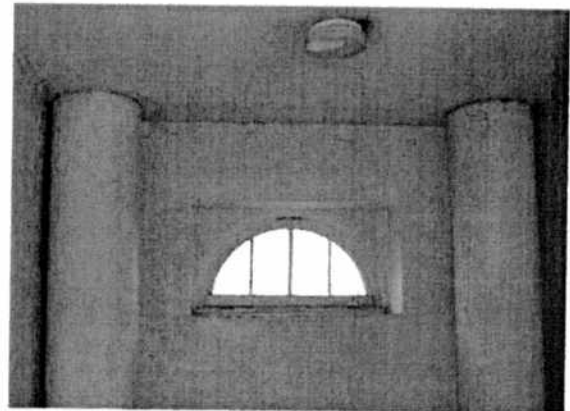
Third Floor: Type 14 Window

Type 14 is a fixed window with missing hardware.

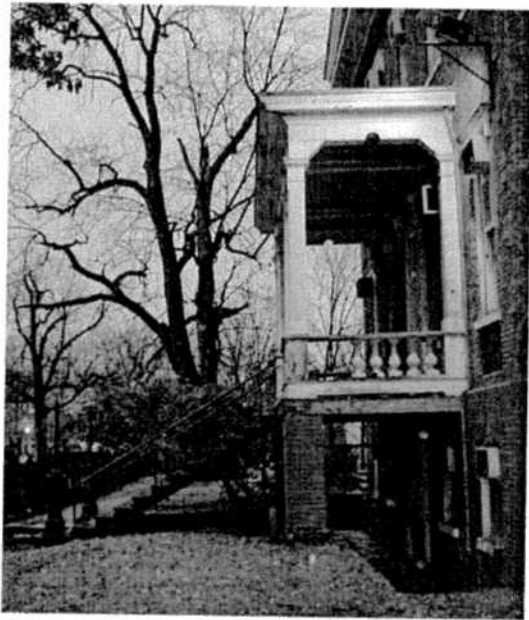
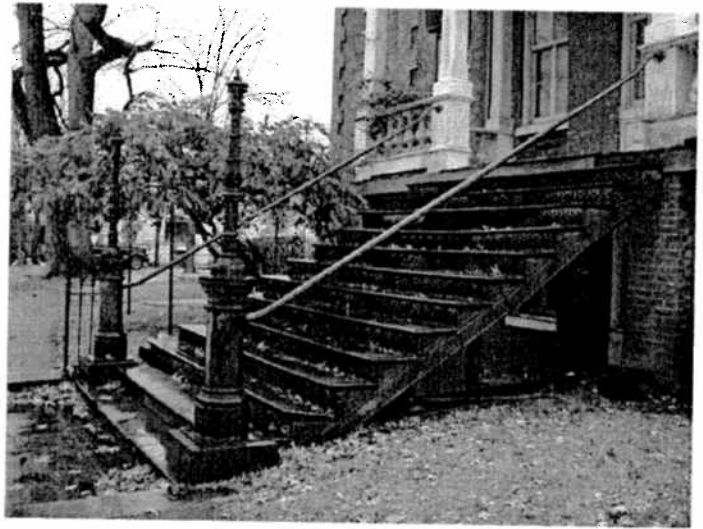
Current: All the cast iron pieces need to be removed and restored. Major cracks in the cast iron stringers and kick plates make the staircase unsafe for use. Most of the clips and fasteners are deteriorated. The gaslight standards are missing the topmost lamp sections. The porch floor is becoming unsafe since it and some of the joists are seriously dry rotted (although many of the joists can be salvaged). The balustrade and pilasters are also in a deteriorated condition. The masonry is also in poor condition and the parging should be removed.

Added: The porch floor, pilasters and balustrades vary in condition and need to be repaired and restored.

Main Exterior Staircase and Portico

- 1) Label and identify all components of the stairs prior to disassembly.
- 2) Completely disassemble the stair case and transport it to the conservation studio.
- 3) Completely strip all coatings (lead positive) using hot caustic dip solution and phosphoric acid.
- 4) Recast all heavily damaged and/or missing risers in cast iron.
- 5) Fabricate new clips and points of attachments for the treads, risers, and stringers.
- 6) Repair by welding all cracked sections of stringers.
- 7) Repair by welding two sections of treads that are presently cracked.
- 8) Completely recoat stairs using powder coat or a paint system consisting of zinc-rich primer, epoxy mastic intermediate coat, and topcoat using aliphatic urethane.
- 9) Transport stairs back to the site and reinstall.
- 10) Provide complete documentation of the work in both written and photographic form.

The two brick piers holding the staircase must be inspected and restored and the masonry retaining wall must be rebuilt and restored to address the deteriorating mortar.

The porch deck must be removed and replaced since there is substantial wood rot in the flooring, and the original joists restored. The end header beams should be redone and the pilasters and balustrade replaced.

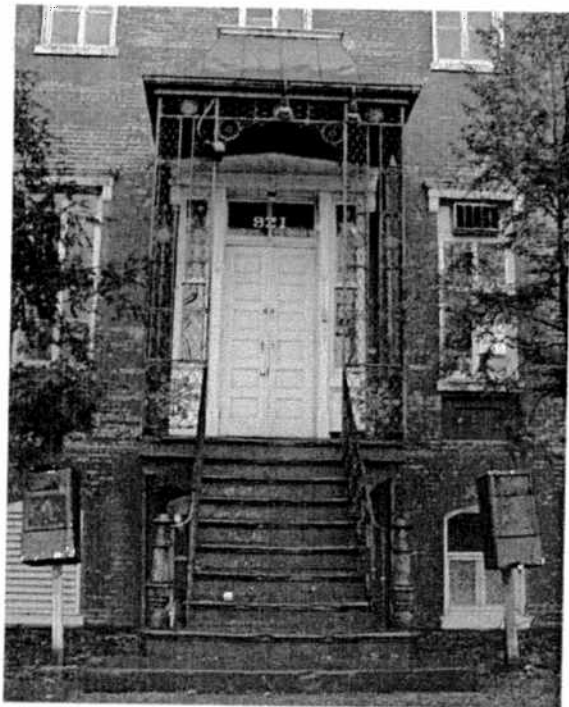
North Facade—The fine wrought iron filigree is in good shape needing only light restoration, the down spouts are nearly non-existent, the guttering has pinholes, the leftmost of the two boot scrapers is damaged, the cast iron newels are in good shape needing restoration, the metal roof over the entrance needs light repair and repainting, the gas fixture needs to be researched and restored and the lightening rod system needs to be repaired and reanchored.

North Façade Staircase and Metalwork

North Facade—The guttering needs to be repaired and the down spouts need to be replaced.

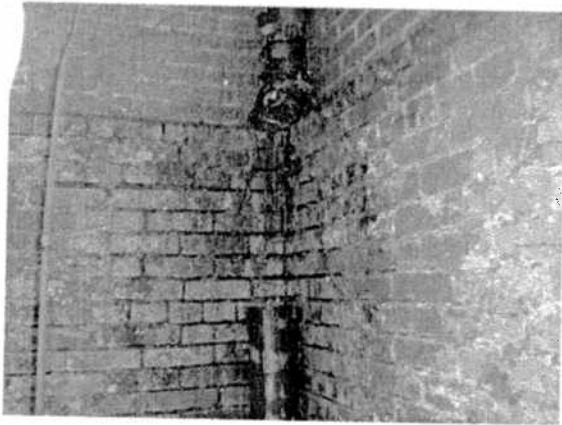
Current: General—The painted brickwork is in generally good shape but with the majority of the paint peeling or off. The bottom six courses have severely eroded mortar due to water damage. Brick damage, caused by improper mortar replacement, exists in various places. In other places, moss and ivy are growing out of the joints, destroying the mortar.

Brick and Mortar Water Damage
